**COMMERCIAL WINDSTORM MITIGATION**  
**INSPECTION REPORT**

QUINCY BUILDING  
TERRACE PARK AT FIVE TOWNS #27, INC.  
8199 TERRACE GARDEN DRIVE N.  
ST. PETERSBURG, FL. 33709

## **RECAPITULATION OF MITIGATION FEATURES**

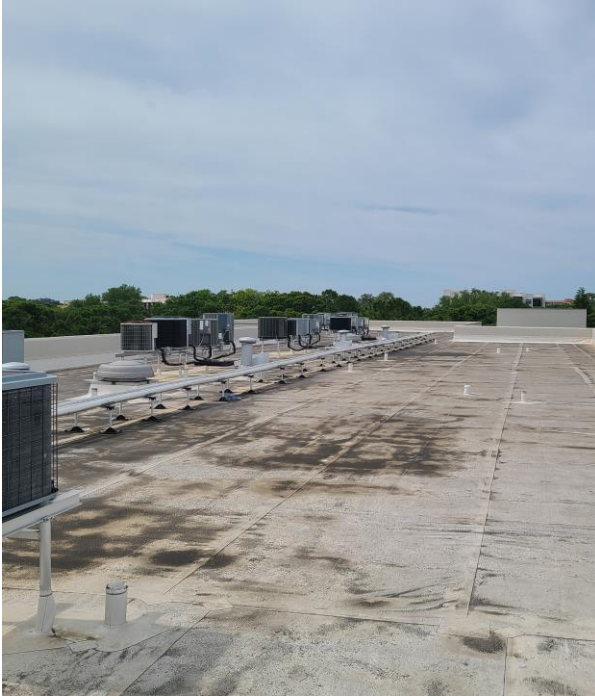
**ROOF COVERING (SECTION 2)**

2. Roof Covering: FBC Equivalent Comments: The roof covering was  
Comments: replaced in 09/29/2020. The roof permit was confirmed at Pinellas County Building Department and the permit number is PER-H-CB20-07340. This roof was verified as meeting the requirements outlined on the mitigation affidavit.  
The Florida Approval # FL16039.1 / NOA 12-0127.01  
Mechanical fasten / screwed to concrete substrate roof deck.

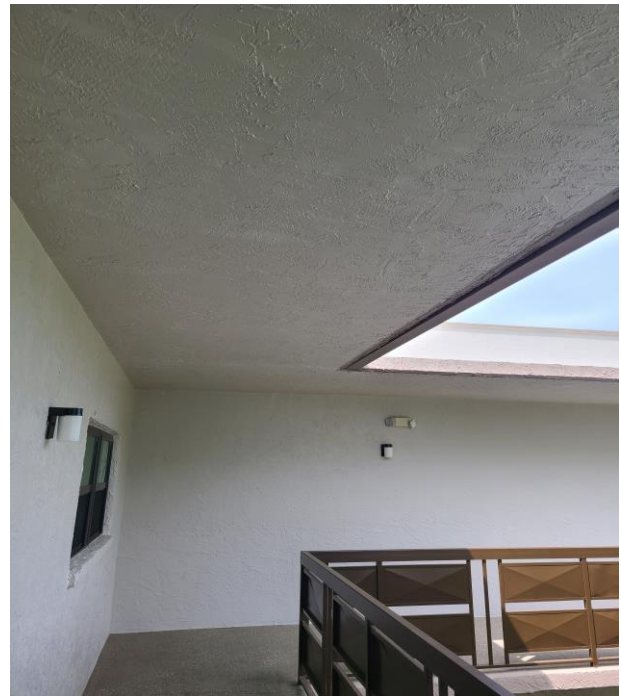
**ROOF DECK ATTACHMENT. (SECTION 3)**

3. Roof Deck Attachment: Reinforced Concrete Roof Deck Inspection verified a roof  
Comments: structure composed of cast-in-place or precast structural concrete designed to be self-supporting and integrally attached to the wall / support system.

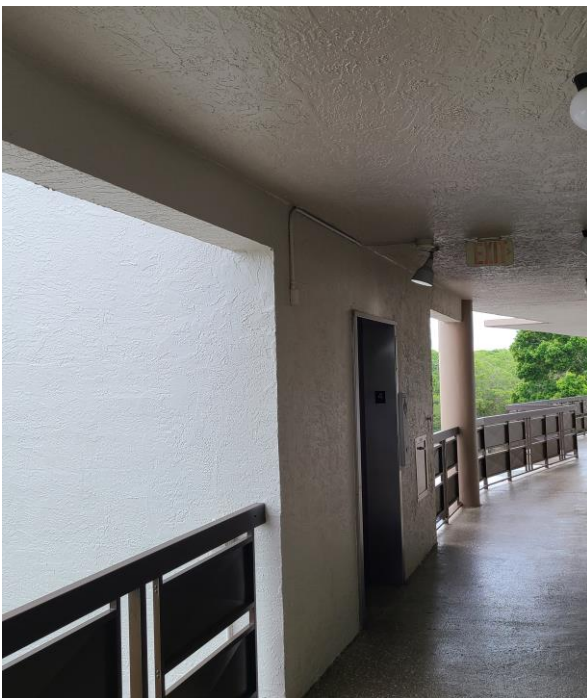
**ROOF TO WALL ATTACHMENT (SECTION 4)**

4. Roof to Wall Attachment: Structural Comments: Inspection verified a roof structure composed of  
Comments: cast-in-place or precast structural concrete designed to be self-supporting and integrally attached to the wall / support system.

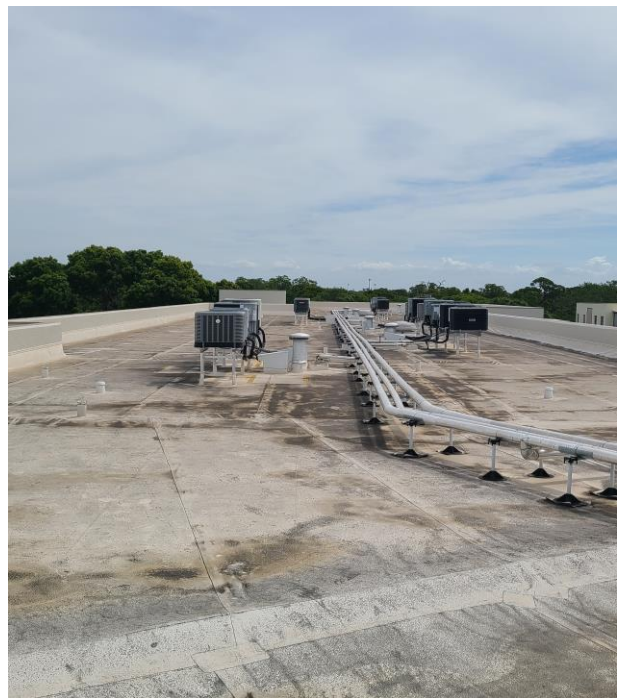
**ROOF COVING & SHAPE (SECTION 5)**

5. Roof Geometry: Flat Roof Comments: Inspection verified a flat roof shape.
6. SWR: Unknown or Undetermined Comments: SWR does not apply to  
reinforced concrete roof decks.

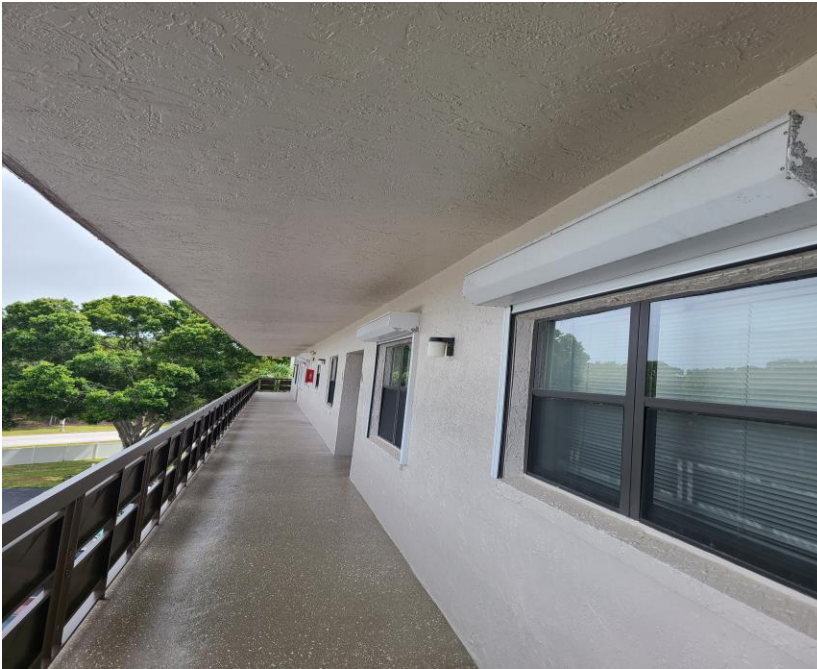
**WINDOW PROTECTION / SOME UNITS (SECTION 7)**

7. Opening Protection: None or Some Glazed Openings Inspection verified  
Comments: some opening protection. Not all glazed openings were protected with impact resistant coverings.  
There are (56-Units Risk) some owners have hurricane shutters.

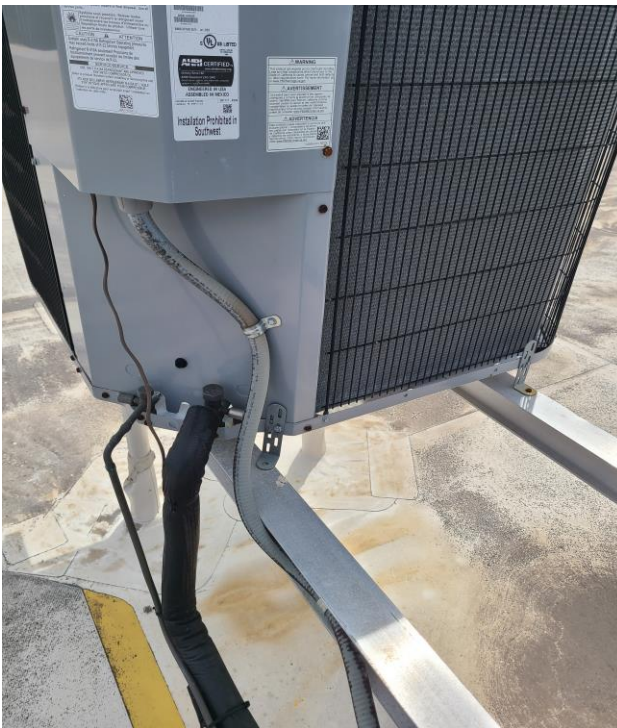
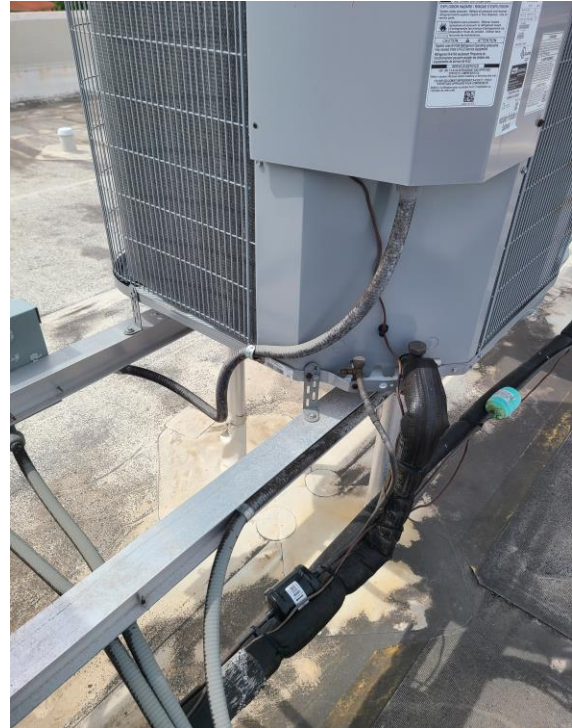
**HVAC CONDENSERS, ALUMINUM STANDS ANCHORED TO CONCRETE SLAB.  
HVAC CONDENSERS SCREW DOWN TO ALUMINUM STANDS.**
